Assessment of Geotechnical Properties of Soil in Capitol Gully Erosion Site, University of Benin, Benin City, Edo state

Original Research Article

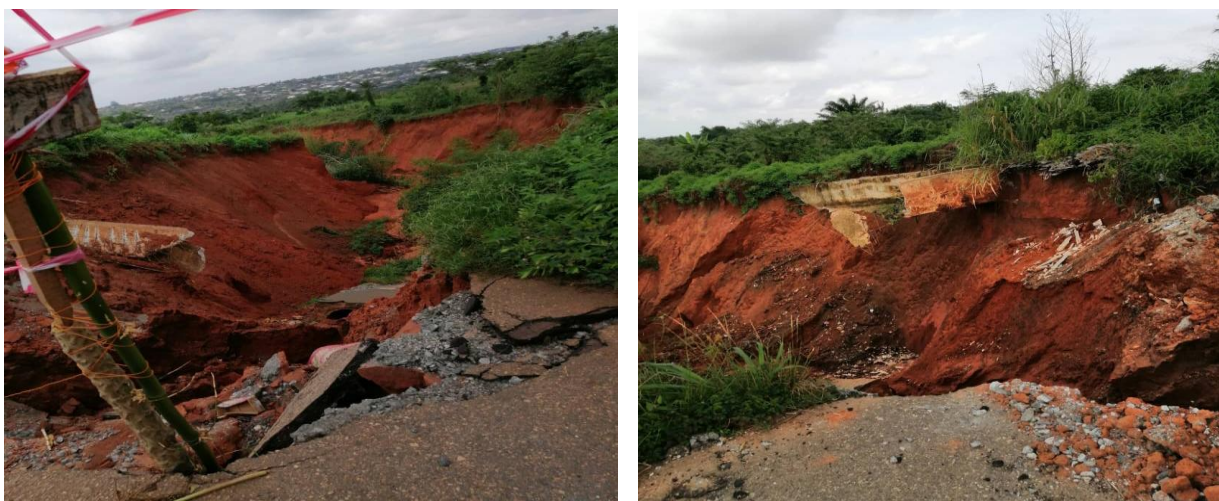
Diagram 2a. Capitol gully erosion site

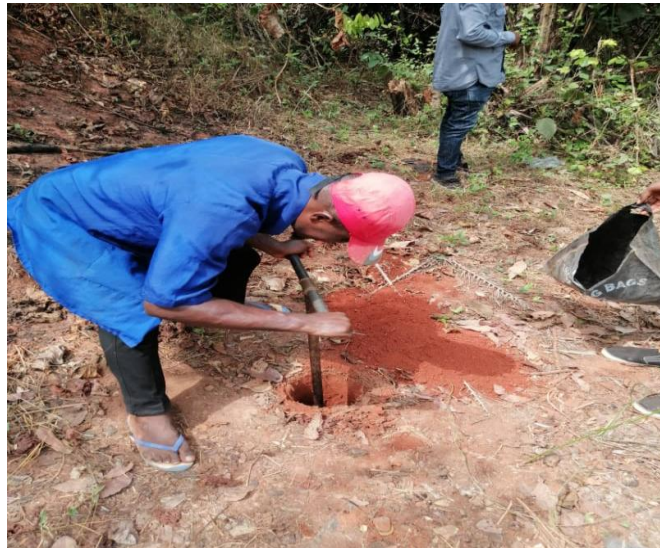
Diagram 2b. Collection of samples at the site

Three (3) soil samples were collected at depths of 1m each which is disturbed samples. Disturbed sample is a sample in which the natural structure of the soil is modified partly or fully during sampling. The following procedures was employed for the collection of disturbed sample that was used for this project.

- i. Drilling with the aid of continuous flight hand auger;
- ii. At a depth of 1.0m each, samples were collected.
