## **Degradation of Crystalline Silicon Photovoltaic Cells/Modules under Heat and Temperature Effect**

**Original Research Article**

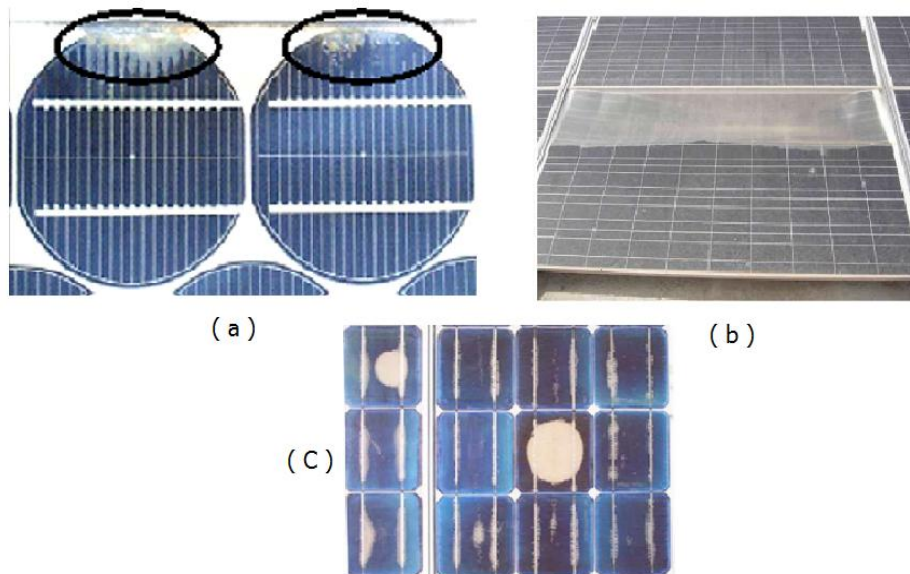
**Fig. 1. (a) PV module delamination; (b)-(C) severe delamination (this figure presents an example of how an extreme delamination could destroy a PV module when the defect appeared after barely a year of functioning) [1,16,17]**

Delamination is very frequent in hot and humid climates. It causes moisture penetration in the PV module and therefore induces various chemical and physical degradations such as metal corrosion of the module structure most frequently. Delamination is more severe if it occurs in the borders of the module because, a part from the power losses causes electrical risks to the module and the installation. Delamination is also related to a transmittance loss, as materials are not well optically coupled and a part of the light escapes [16-19] (Fig. 1).

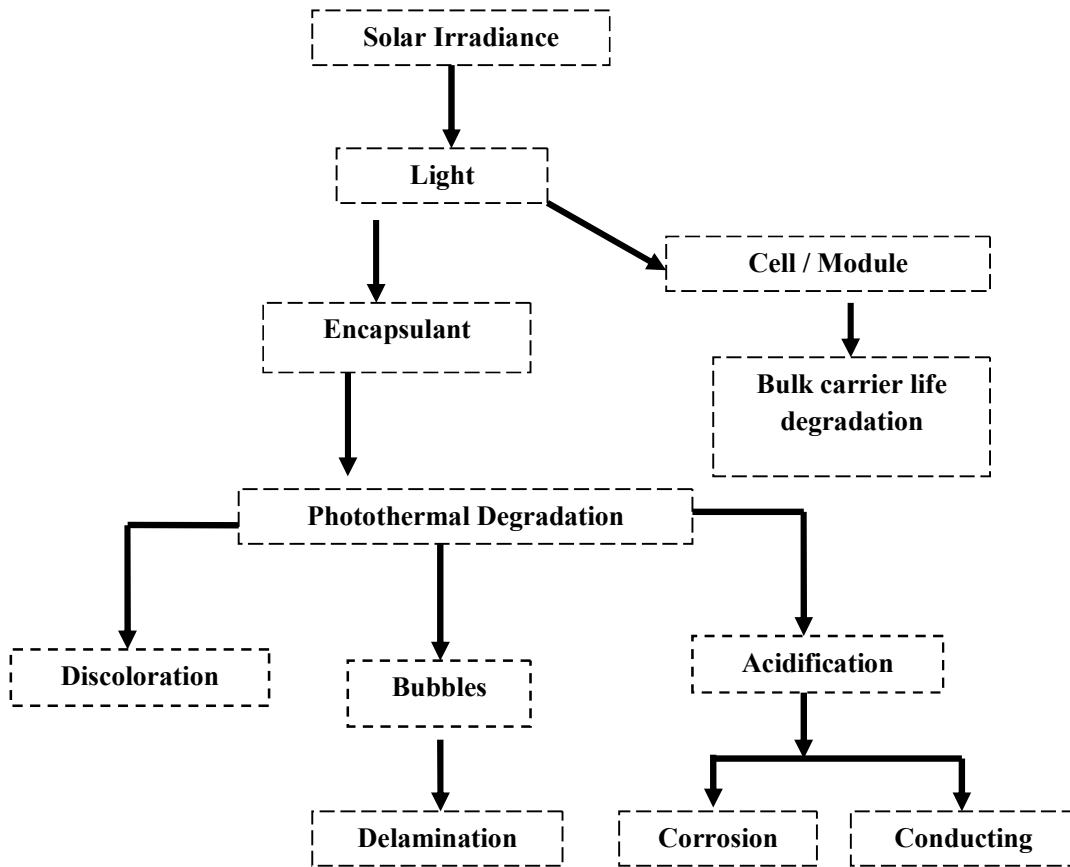
Fig. 6. Light-induced degradation

Possible degradation mechanisms under irradiance are presented in Fig. 6. Light induced degradation is one of the main ageing mechanisms. More research is required to understand the mechanisms and kinetics of PV module discoloration as well as the induced power losses. Besides discoloration, bubbles are another concern for encapsulant photo-thermal degradation. In the process of photochemical degradation, gases of different types can be generated with a potential to cause delamination which can enhance water ingress and cause further problems such as decoupling of light transmission and reduction of heat dissipation. Another problematic reaction product generated during photochemical ageing is acid such as acetic acid and carbon dioxides.
